### Replacement of Seat Adjustment Isolator Pad

Z3

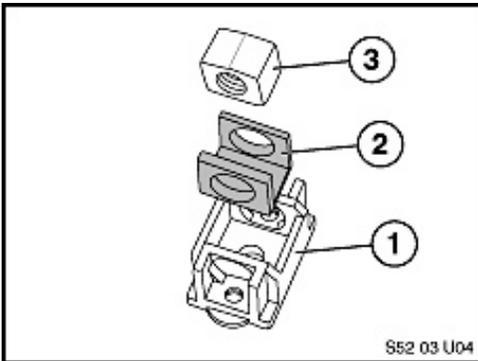
Some customers may complain that either seat seems to slide back and forth slightly under braking and acceleration. The urethane isolator pad used in the fore and aft seat adjustment assembly may compress or wear over time, causing excessive play in the mechanism.

Remove the center section (3) and the isolator pad (2) from the nut assembly (1). Install the new isolator pad and reinstall the center section of the nut. Lubricate the adjustment screw with Wurth Glide grease, article number 0893898. Use an acid brush to distribute the grease over the entire surface of the screw threads.
